**NAVAL  
POSTGRADUATE  
SCHOOL**

**THE MITIGATION OF RADIO NOISE  
FROM EXTERNAL SOURCES**

**at  
RADIO RECEIVING SITES**

**6<sup>TH</sup> EDITION**

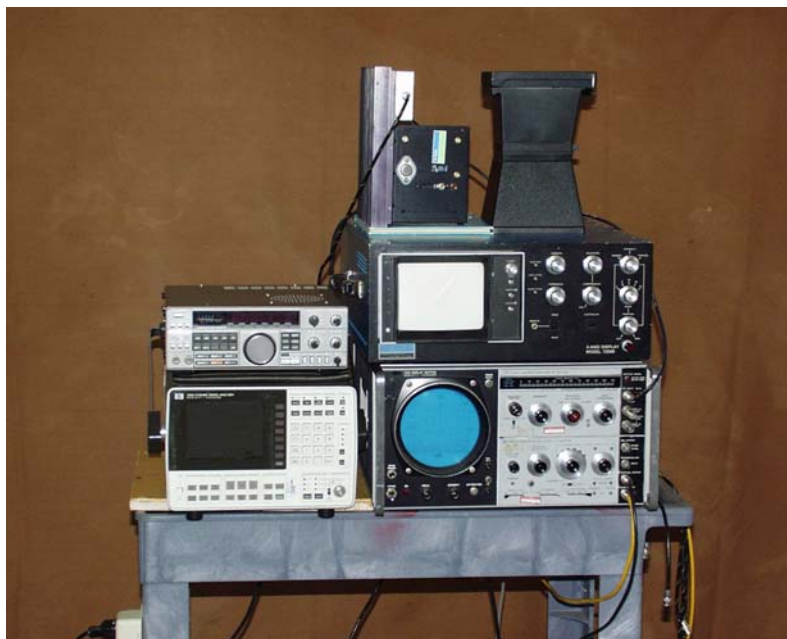
**Figure 6      Photograph of Typical Site Instrumentation**

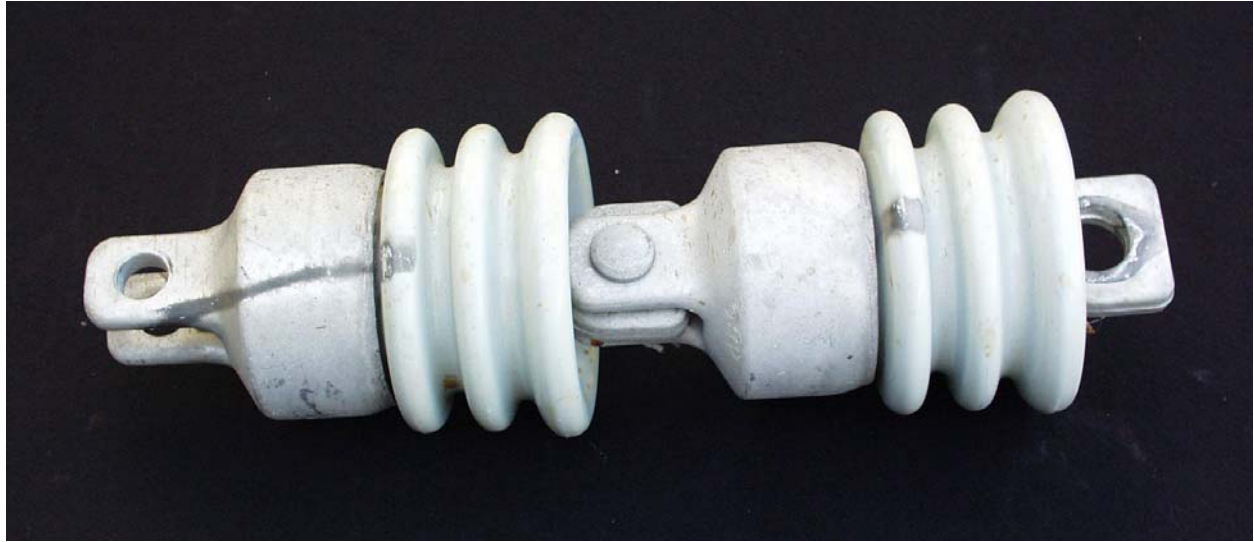
Many sources of radio noise have been traced to the bell insulator. Figure 32 shows a two-section bell insulator used on distribution lines. Single, dual, and triple bells are commonly used on distribution lines operating at 10- to 40-kV phase-to-phase or phase-to-ground potentials. Single bells are commonly used on lines operating at voltages of 13 kV or less.

**Figure 32 Bell Insulator**

The particular bell insulator shown in Figure 32 was removed from service because of lightning damage. A long burn mark is visible on the metal portion of the left section along with a short streak on the left rib of the left porcelain insulator. Another short streak is visible on the first rib of the porcelain at the right end of the bell. In addition, the clevis on the right end of the insulator shows burn damage around its hole. These visible marks on the insulator were caused by a flashover from a direct lightning strike. Apparently the flashover jumped over the center of the insulator.

The bell insulator is rugged, has a long life (typically 40 years or longer), does not significantly deteriorate with exposure and age, retains its insulation properties with age, normally tolerates flashovers from lightning, and is inexpensive. These desirable properties have made the bell insulator a popular item with many utilities and public works departments. Yet, the bell insulator has gradually been recognized as a major source of radio noise. Because of this, some utilities are now using other types of insulators to replace bells.

The burn marks did not result in radio noise, and thus were of no concern to noise-mitigation personnel or to the operation of a nearby radio-receiving site. The decision to replace

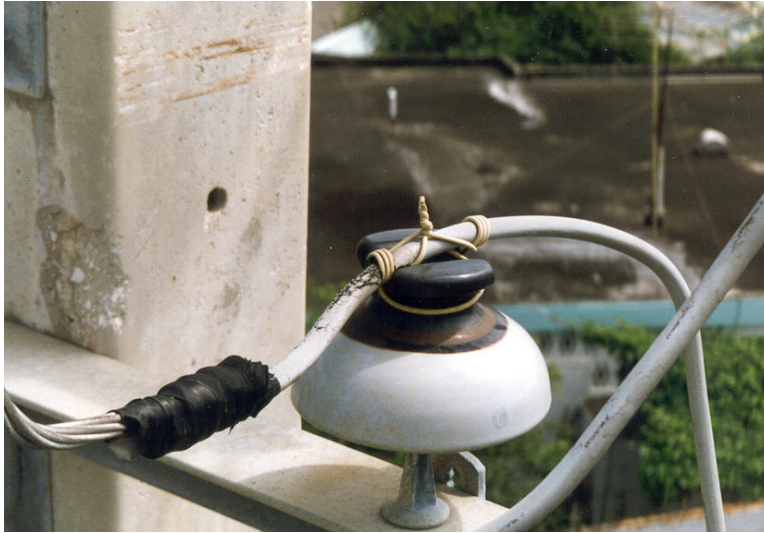
**Figure 35      Insulated Tie Wire on an Insulated Conductor**

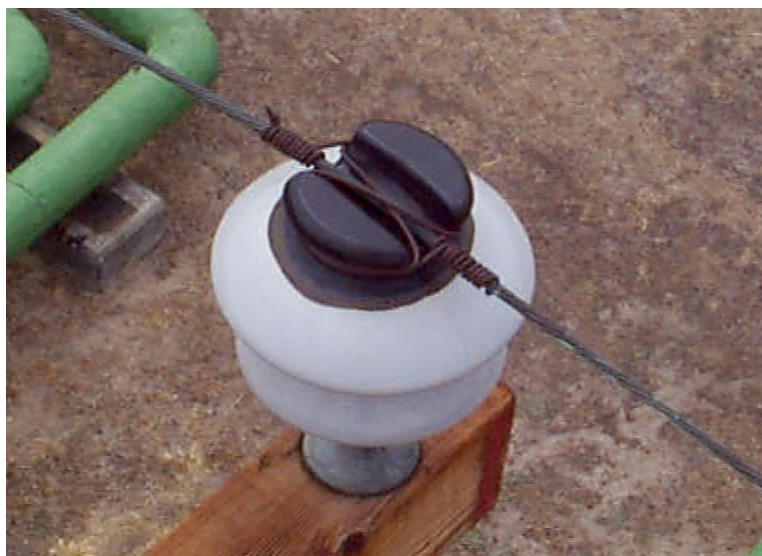
**Figure 36      Insulated Tie Wire on a Bare Conductor**

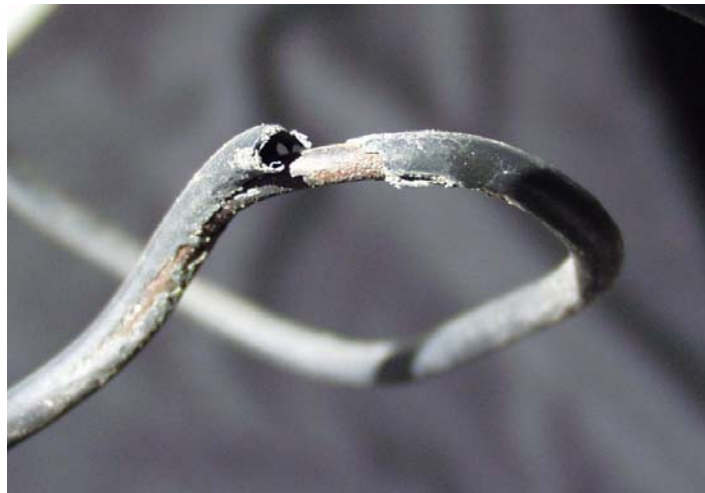
**Figure 37      Insulation Failure at a Bend in a Tie Wire**

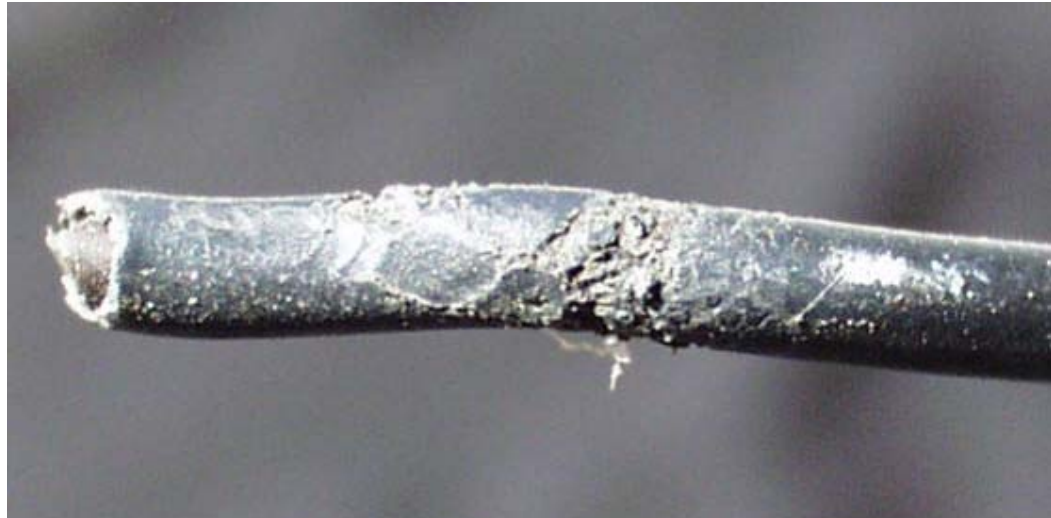
**Figure 38      Insulation Failure at the End of a Tie Wire**

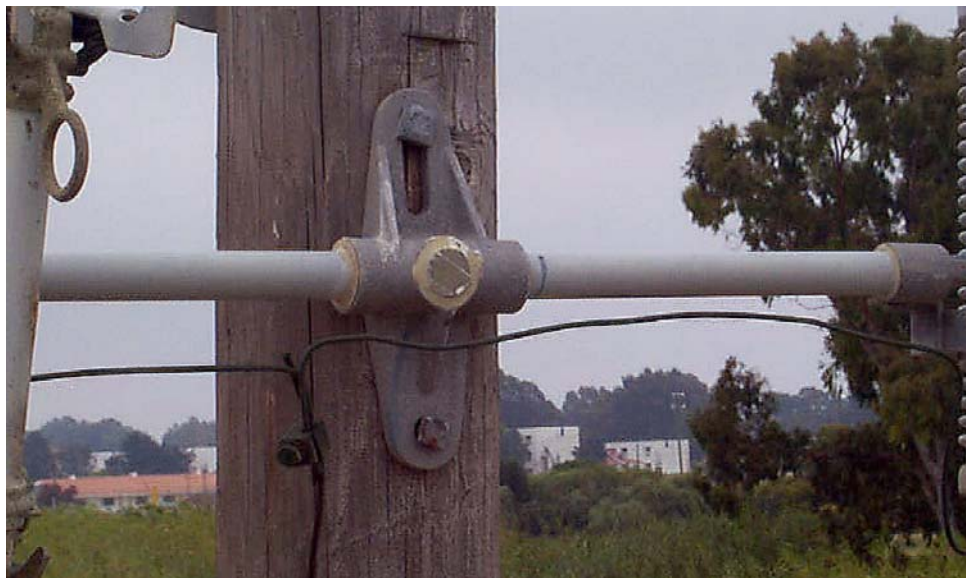
**Figure 41      Hardware Source, Example 2**

Figure 41 shows a source where a ground wire used to bond metal components together passed over the metal brace supporting a plastic crossarm. A small spark occurred between the ground wire and the brace. This induced noise current into the ground wire and other nearby objects. The length of the ground wire was sufficient to make it an efficient radiator of the noise.

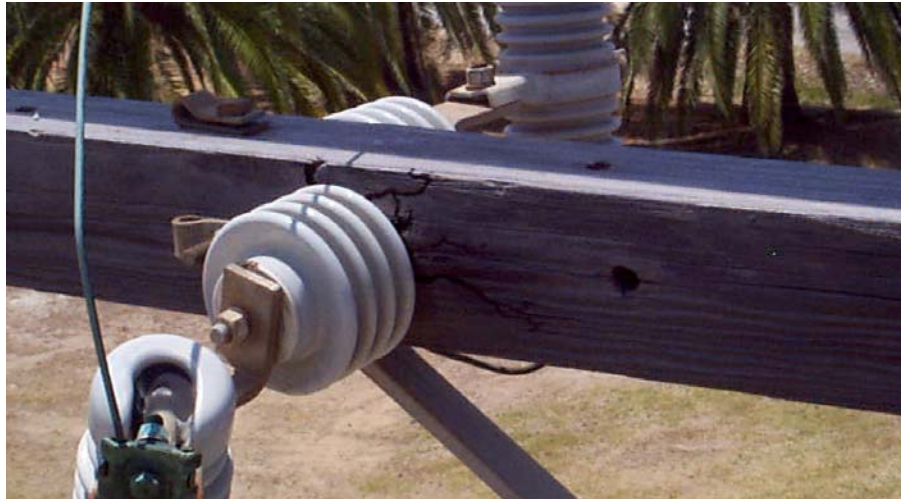
**Figure 42      Hardware Source, Example 3**

Figure 42 shows still another example of a hardware source. A close inspection of the wood behind the insulator shows extensive cracking and dry rot. This loosened the support bolts and associated hardware, and allowed sparking and micro-sparking sources to form on the insulator support components. Occasional puffs of smoke were seen emanating from the cracks due to the conduction of carbonized wood.

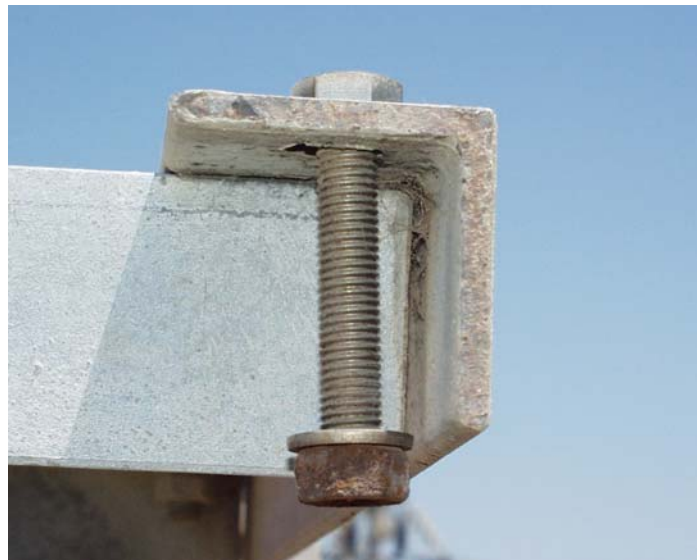
**Figure 43      Hardware Source, Example 4**

Figure 43 shows still another example of a hardware source. In this case the line construction crew carelessly left a loose bolt in a hole on the end of a metal crossarm. Movement of the bolt from wind or pole movement caused an intermittent and erratic micro-sparking source to exist.

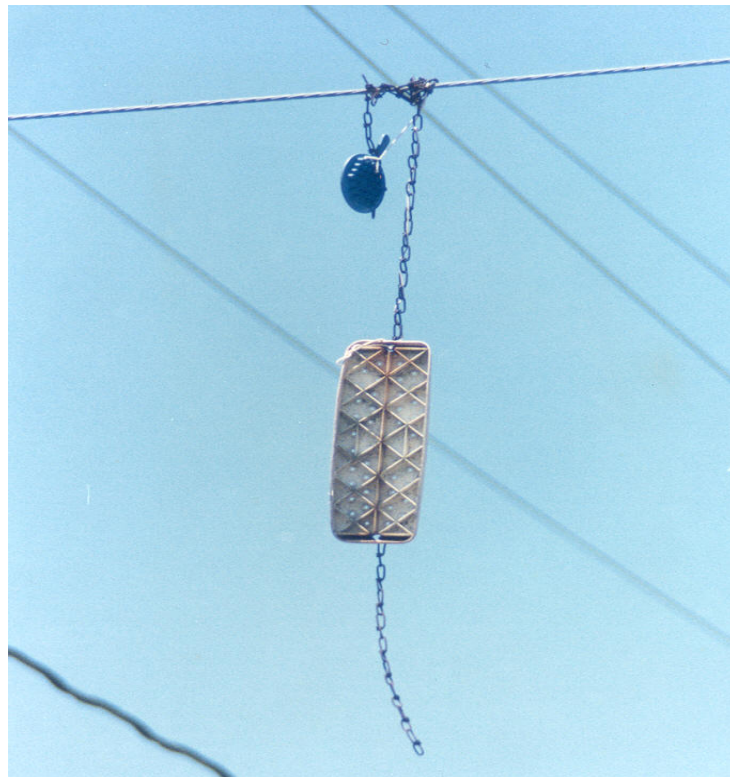
**Figure 44      Debris on a Distribution Line Conductor**

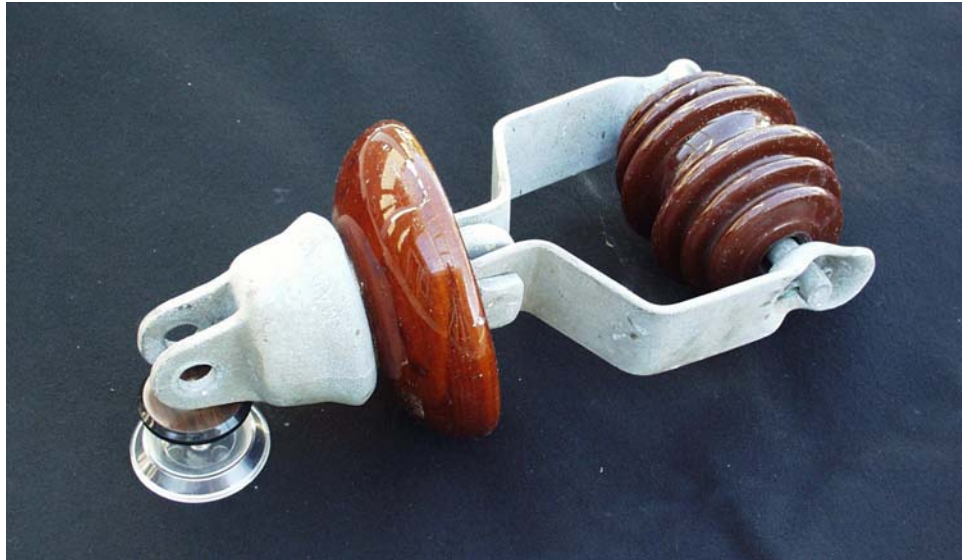
**Figure 45      Spool Insulator**

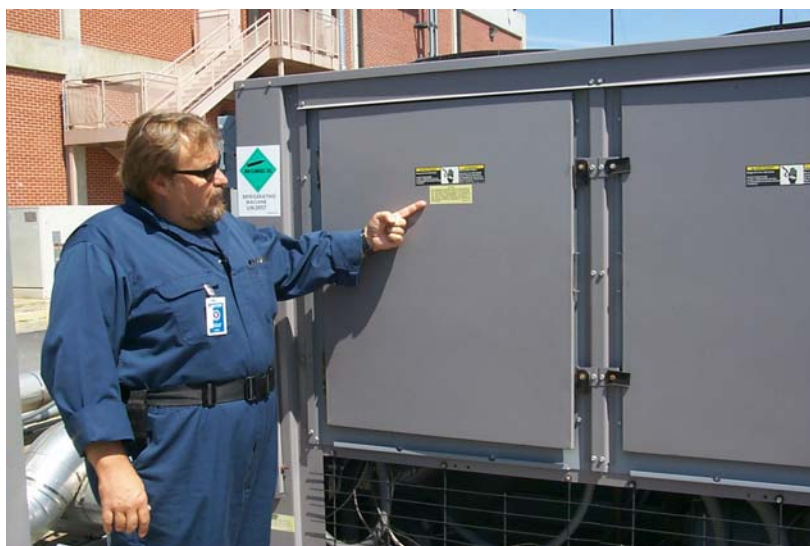
**Figure 48      Housing for Variable-Speed Motor Controller and Motor**

Figure 48 shows the outside housing for the controller and motor of an air-conditioning system of a large radio-receiving facility. A radio-noise specialist is pointing at the Class A warning notice on the housing that clearly indicated this device was a likely source of radio noise. The controller injected high levels of noise current onto the outside surface of the housing, onto pipes leading to and from the housing, and onto the conduits providing power to the controller. Radio noise emanating from these conductors was intercepted by the site's antennas and fed to its receivers, resulting in severe interference to the reception of radio signals.

The variable-speed controller for the air-conditioning motor for this installation was intended for use in an industrial facility, and it was properly labeled for that type of use. The controller was improperly installed at an HF radio-receiving site where it caused severe radio interference as indicated by its warning label. This is a clear example of poor site engineering. Only devices approved for Class B residential use should be considered for installed at locations at or within line of sight of radio receiving sites. Noise measurements should be performed on selected examples, and low-noise devices selected for critical tasks.

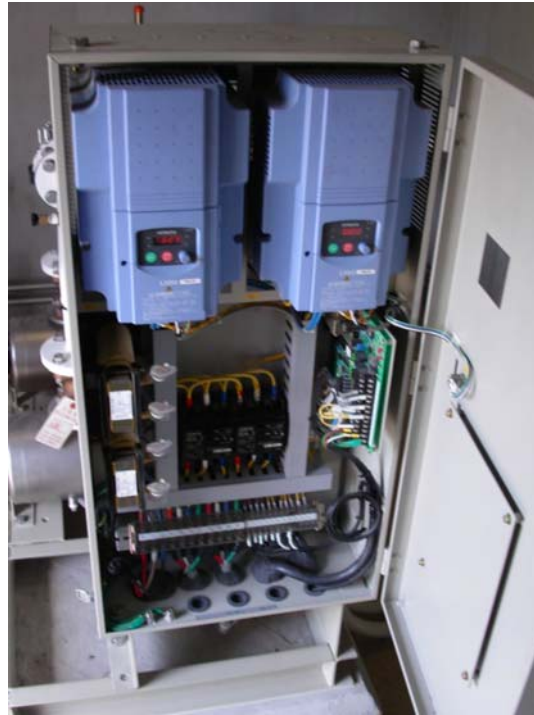
**Figure 49 Variable-Frequency Controllers for Two Electric Motors**

Figure 49 shows another example of a source of radio interference at a receiving site from a power-conversion device. The photograph shows the controllers for two variable-speed electric-motors used to control the flow of water from a nearby storage tank into the local-area water-distribution system. Electric power enters the controller enclosure at the bottom. The motors are located directly below and behind the controller. Variable-frequency electric-power is provided to the motors by short conductors that also exit from the bottom of the enclosure.

In this case the controller injected switching impulses onto the building wiring, the impulses were conducted to an outside pole transformer, passed through the transformer and onto the overhead distribution line conductors. Radiation from the overhead-line conductors caused radio noise at a receiving site located several km away.

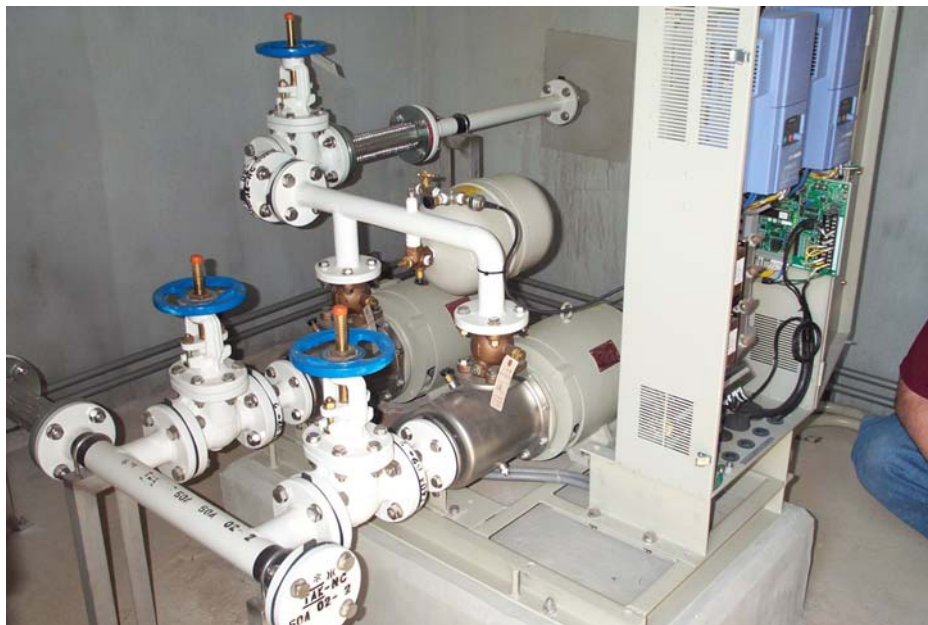
**Figure 50 View of Variable-Speed Motors and their Loads**

Figure 50 shows the motors and the water-control valves associated with the controller in the previous figure. The motors are standard fractional horsepower induction motors that are widely used in many kinds of low- to modest-size variable-speed applications.

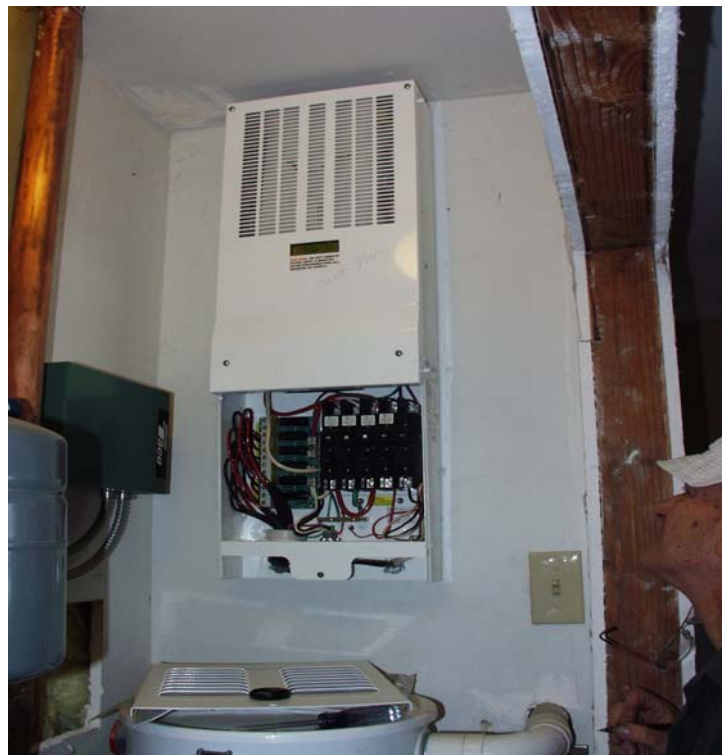
**Figure 51      Solar Power Converter**

Figure 51 shows the controller used to convert direct-current voltage from solar cells into alternating current at the frequency of the power provided by an electric utility. In this case the controller was used in a residence where solar-generated electricity was used to supplement power from the electric utility serving the area. High levels of switching impulses were injected onto the conductors running from the controller to the roof-mounted solar cells, and radiation from these conductors resulted in severe noise to a receiving site located more than a km from the source.

The controller shown in Figure 51 did not contain a FCC Class A or B label. Because of this it was a unit improperly marketed in the United States. This particular model is no longer available, but it raises questions about similar units that are built with no consideration of man-made radio noise or of units built to FCC Class A specifications that find their way into residences. Several complaints of radio noise from such devices have been reported, and in most cases the resident had insufficient knowledge and background to understand the implications of the noise ratings.

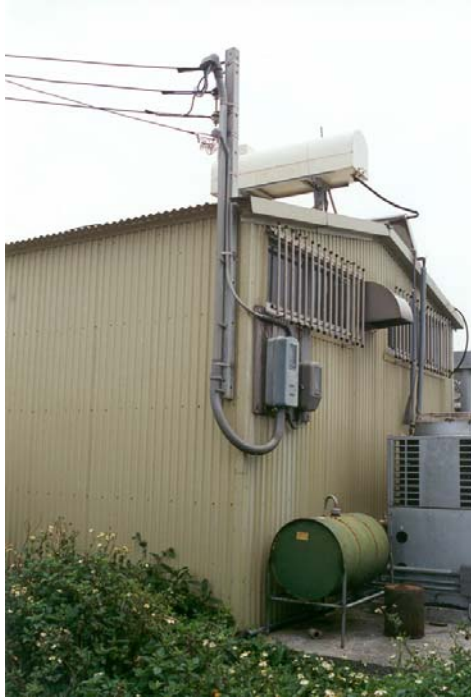
**Figure 53      Power Feed for Hydroponics Farm**

Figure 53 shows the external electric power feed into the building containing the hydroponics farm. The controller was located inside the building on the inside of the wall shown in photograph. The power drop was connected to an overhead pole transformer located about 30 meters from the building, and the overhead line feeding electric power to the transformer ran along the road in front of the building. Controller-generated radio noise radiated from the overhead distribution line.

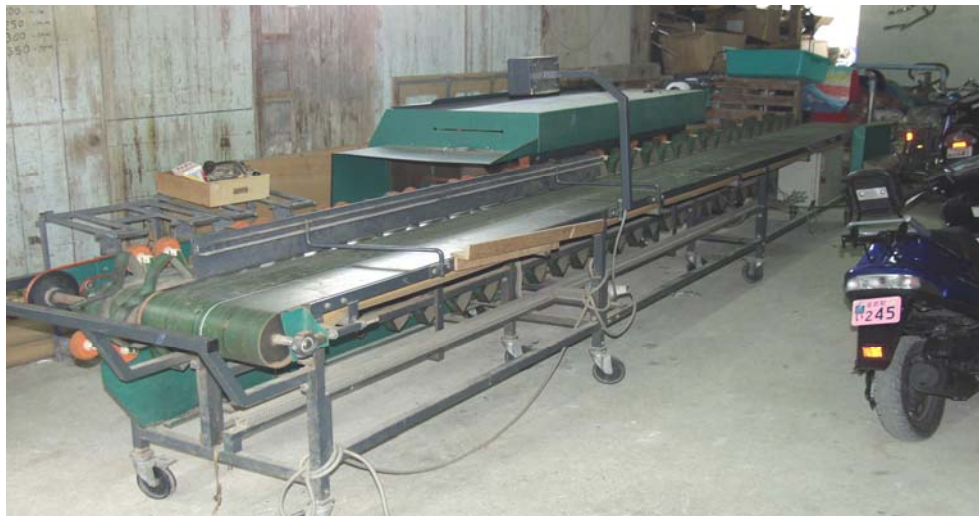
**Figure 54      Photograph of Flower Processing Machine with Variable-Speed Drive**

Figure 54 shows the conveyor belt associated with a machine used to sort, process, and prepare flowers for shipment to sales outlets. The speed of the conveyor belt is controlled by a solid-state variable-speed motor controller. The enclosure housing the power-conversion electronics is the grey box under the belt and to the left of the seat of the motorcycle that was parked in the facility. The motor is located under the belt and is not visible in this photograph.

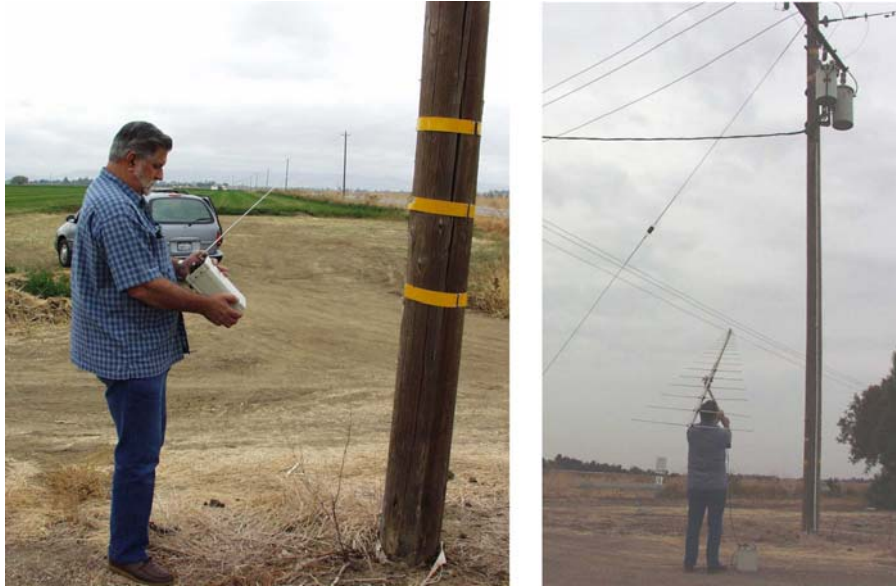
**Figure 57      Source-Location Using the Model 240 or 242 Locator**

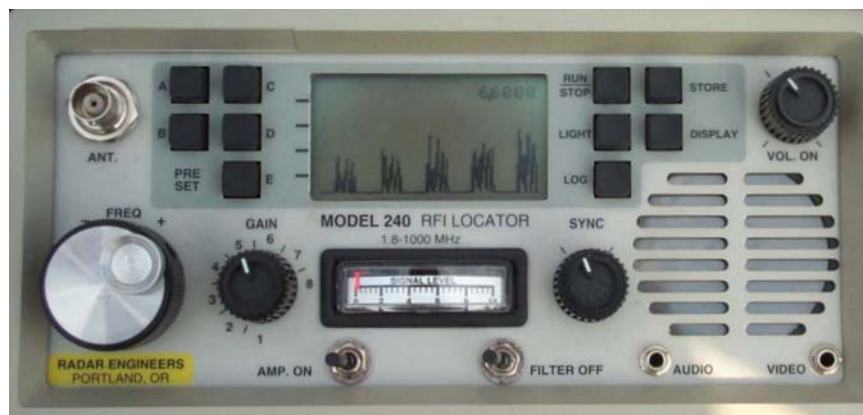
**Figure 58      Temporal Display on Model 240 Receiver**

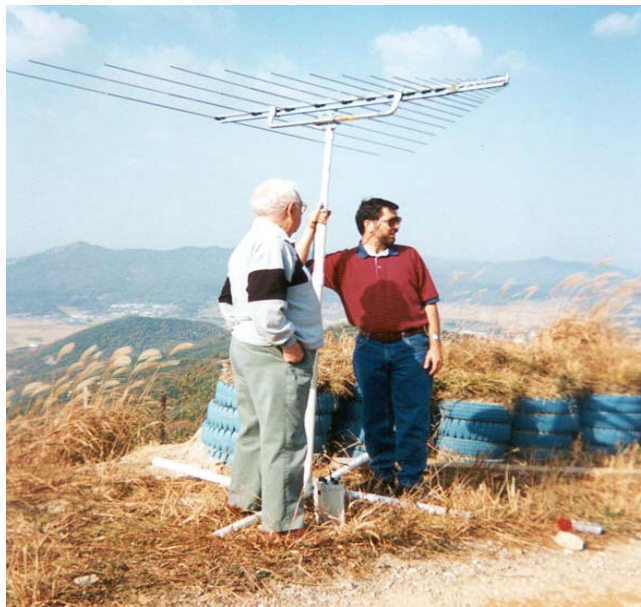
**Figure 59 Hilltop Source Location with RFI Locator**

Still one more technique can sometimes be used to locate poles containing noise sources. Figure 59 shows a Model 240 RFI Locator on a hilltop overlooking a distribution line. The log-periodic antenna is pointed at the distant distribution line and slowly scanned along the line for noise. Poles on the distant line must be visible from the hilltop. Repeated scans at higher and higher frequency will allow sources on individual poles to be located by this technique with the RFI Locator at distances up to about 1 km from a distribution line.

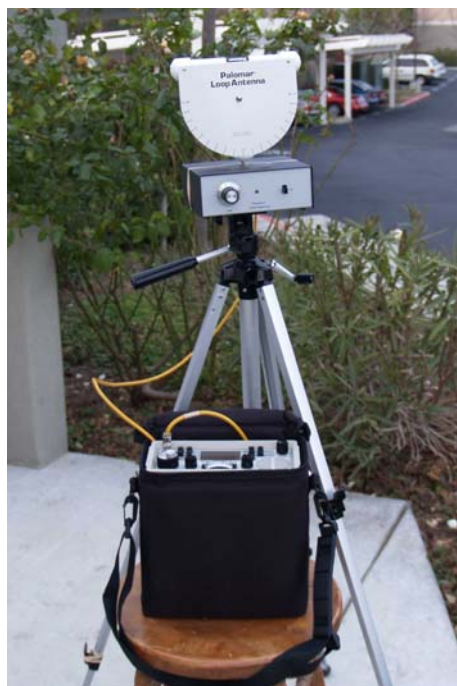
**Figure 60** Loopstick Antenna for Location of Power-Conversion Sources

Figure 60 shows a commercially available loop stick antenna mounted on a tripod to obtain direction to a power-conversion source located in a residential area. In this case a tunable loop stick built for use at the low end of the HF band was used. A Model 240 RFI Locator is shown below the antenna, and it shows the temporal structure of noise from a power-conversion device on its display. If multiple sources exist, they can easily be sorted because of differences in their temporal structures, and the direction to each source can be determined. While some practice is needed to find the null off the end of the loop stick or the maximum off the side of the loop stick, the technique can be highly effective in determining the direction to sources.

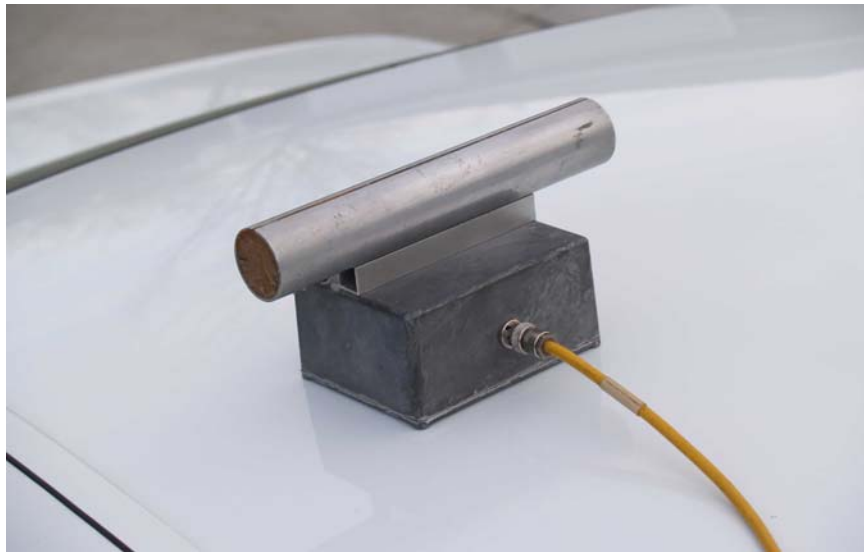
**Figure 61      Loopstick Antenna on Roof of Source-Location Automobile**

Figure 61 shows a photograph of a medium-frequency loop stick on the roof of a search automobile along with a Model 242 Noise Locator and held in place with a magnet. The loopstick is normal to the power line as the vehicle moves along a road to maximize its sensitivity to radiation from the power line. A Model 242 RFI Locator is in the vehicle where its display and audio output can be monitored.

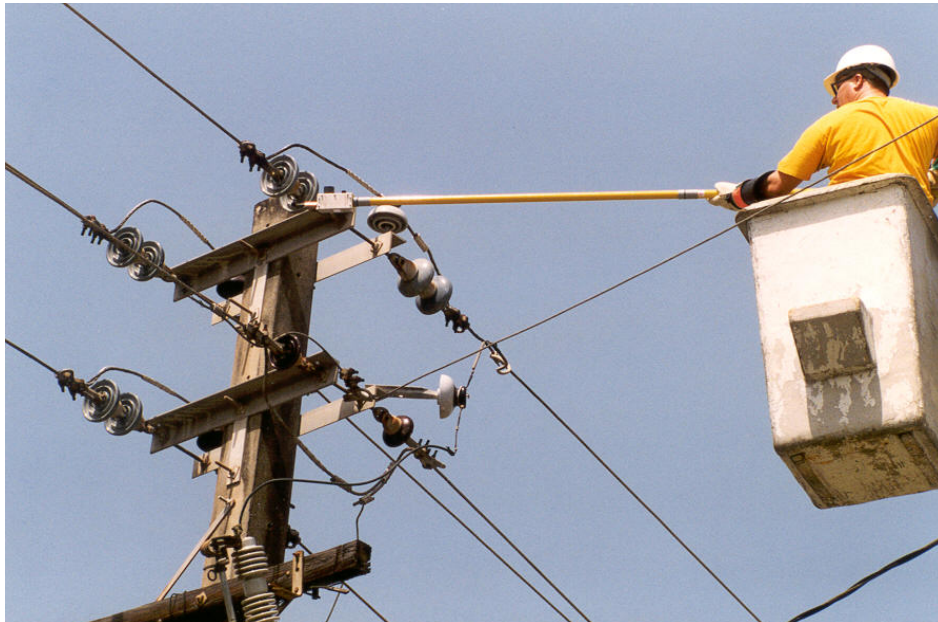
**Figure 62      Source Identification with a Noise Sniffer**

The Radar Engineers Model 247 Noise Sniffer is used by the authors and their associates as well as by many electric utilities. It is mounted on the end of a distribution-line rated hot stick. Figure 62 is a view of the instrumentation and equipment used for the identification of pole-line hardware containing noise sources.

The noise sniffer is fastened to the end of the hot stick and is simply moved around the hardware on the pole until the strongest signal is obtained. This can best be accomplished by elevating the noise sniffer operator to the vicinity of the hardware with a utility-rated bucket truck. In the example shown in Figure 62, the source is located on the clevis pin between two sections of a bell. Never use an ordinary bucket truck designed for general construction work or for telephone line work since these are not insulated for operation near high voltages.

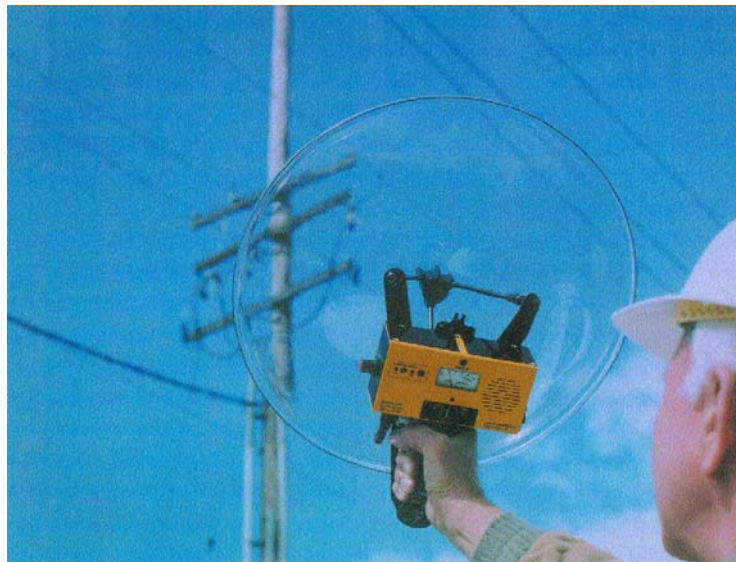
**Figure 63      Ultrasonic Parabolic Pinpointer**

Still one more technique is available for identifying source hardware. An ultrasonic dish is available from Radar Engineers that is effective at identifying the hardware associated with some sparking sources. Figure 63 is a photograph of the Model 250 Ultrasonic Parabolic Pinpointer pointed at a sparking source on a pole. It can detect radio noise from sparking sources from the ground as long as the source is in line of sight of the dish. Thus, it is useful to walk around a pole suspected of containing a sparking source to maximize noise detection and source identification.

While the Ultrasonic Pinpointer is primarily useful in identifying sparking and corona sources on transmission lines, its small size and light weight of the device make it very useful to carry along overhead distribution lines for preliminary searches for sparking sources.

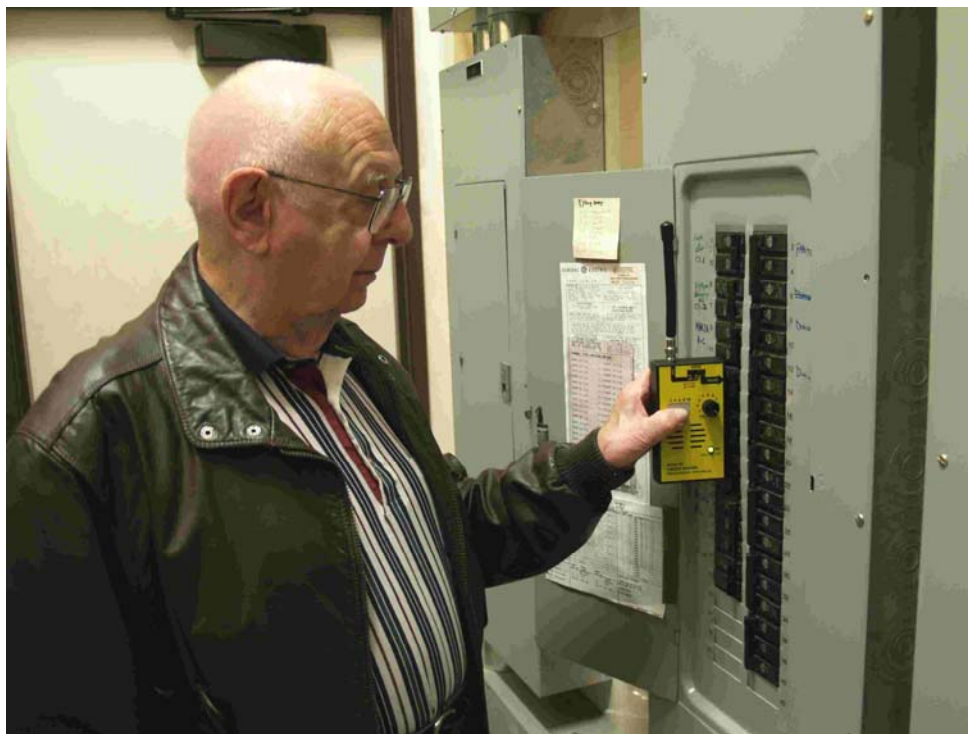
**Figure 64 Using the Model 245 Circuit Sniffer**

Figure 64 is a photograph of the Model 245 Circuit Sniffer in use at a small facility where a switching power supply on a fiber-to-wire converter caused radio interference to a nearby receiving facility. The circuit breaker carrying radio noise was quickly identified and its conductors were traced to the offending source of noise. Turning the power-supply off at the converter verified it was the source of the noise.

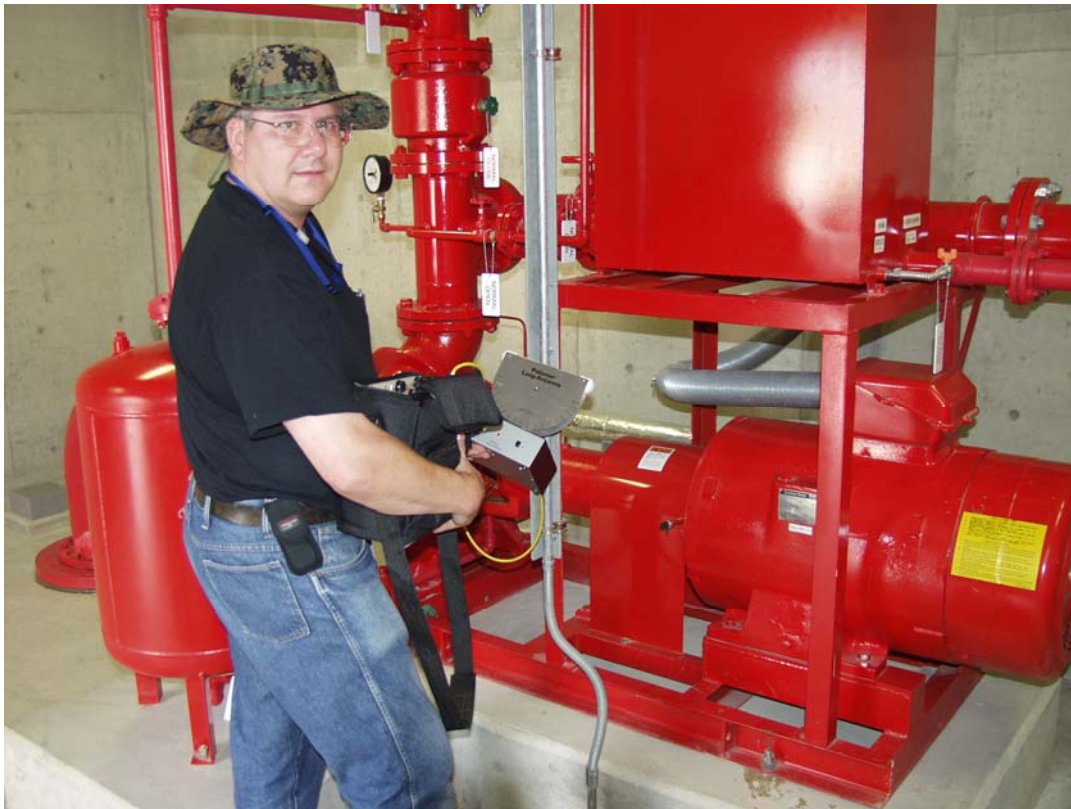
**Figure 65      Using the Model 242 RFI Locator and Probe**

Figure 65 shows the Model 242 RFI Locator in use with a loop stick antenna to identify conductors associated with a power-conversion device that carry excessive levels of EMI current. The conduit near the loop stick carried significant levels of broadband conducted noise current from a variable-speed motor drive located to the rear of the operator. This instrument and the similar Model 240 RFI Locator have also been used with other antennas and probes with excellent results.

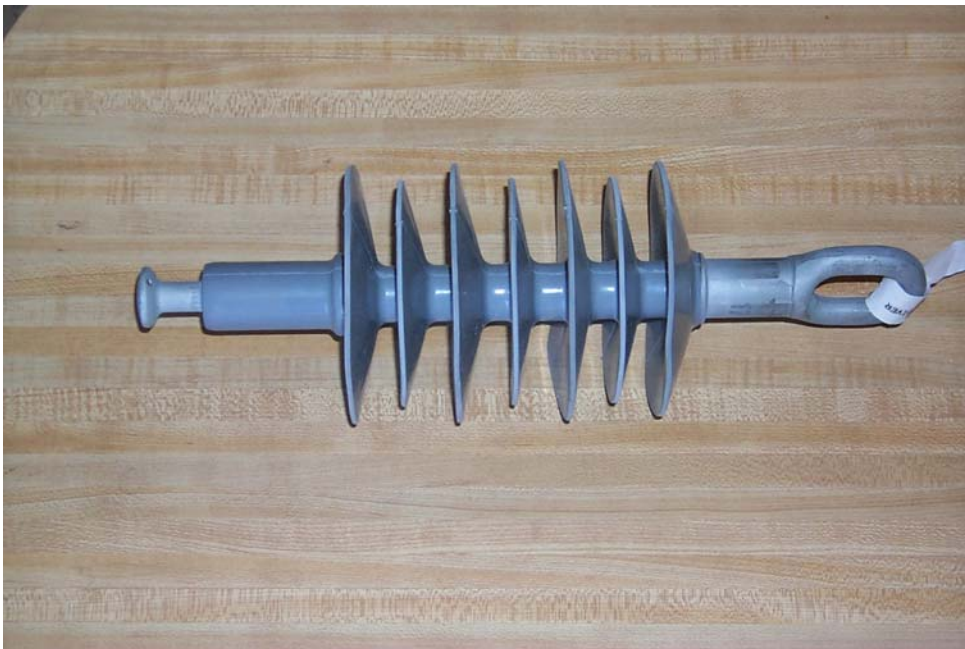
**Figure 67**      **Example of a Polymer Insulator**

Figure 67 shows an example of a polymer insulator. Variations will exist in the configuration of a polymer from one model to another, but all contain a fiberglass rod covered by a weatherproof polymer material. Metal components on each end of the insulator are attached by compression onto the fiberglass rod. Since the end-to-end capacitance of a polymer insulator is extremely low, sufficient charge cannot accumulate on the metal components at the ends of the insulator to support a microspark type of noise source.

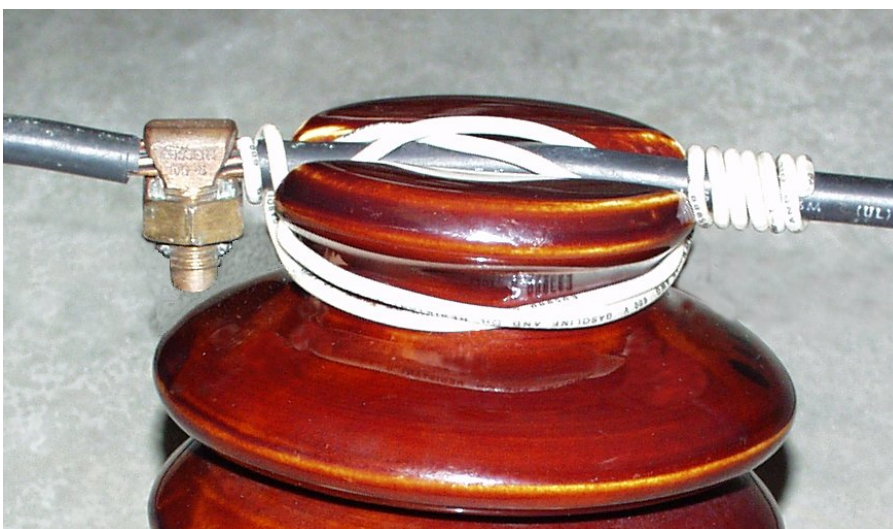
**Figure 68** Tie Wire Source Mitigation, Example 1

Utility personnel usually replace a damaged tie wire with a new tie wire. This is only a temporary solution since the process that initiated the original arcing is often repeated. The only effective way to permanently eliminate such a source is to eliminate the potential difference between the tie wire and the line conductor. Figure 68 shows a method of eliminating the potential difference where the tie wire is electrically connected to the line conductor with a bronze cable clamp. In this example an insulated tie wire is used on an insulated line conductor. A short portion of the insulation on both the tie wire and the line conductor was stripped to allow the bronze cable clamp to be attached to both conductors.

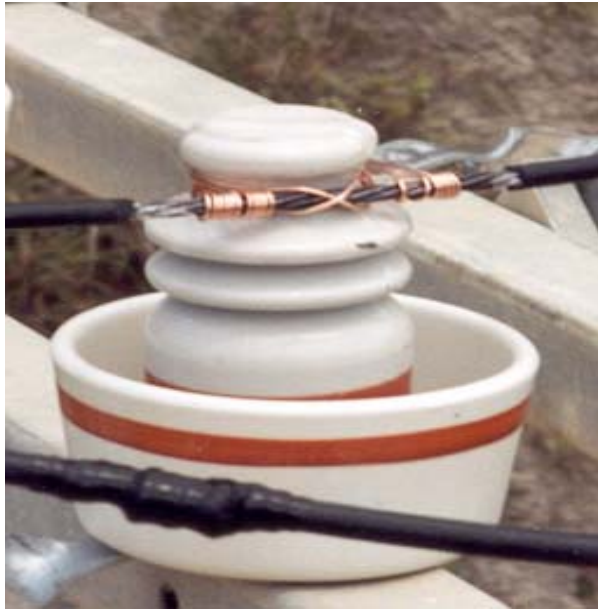
**Figure 69      Tie Wire Source Mitigation, Example 2**

Figure 69 shows another example where the tie wire is electrically connected to the line conductor. In this example, a bare tie wire is used on an insulated line conductor. The line conductor was stripped of its insulation where it was attached to the insulator.

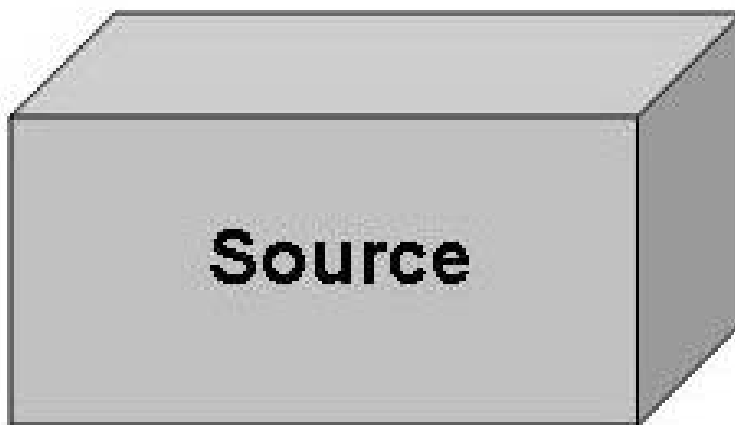
**Figure 70 Source Enclosed within an Electromagnetic Barrier**

Figure 70 shows the start of this process where the source is completely enclosed within an electromagnetic barrier.

Figure 70 describes a somewhat impractical case since power must be provided to the source, a ground must be provided, the source probably will be connected to other devices, and conductors are often required to control the operation of the source. Figure 71 shows how power can be applied to a source. A filter can be installed directly onto the metallic surface of the enclosure and power can be provided through the filter. The filter allows electric power to be provided to the source at low loss while the higher-frequency noise is attenuated and cannot be conducted onto the outside power conductors. Small and inexpensive filters can be used on low-power sources, but large filters will be required for high-power sources.

It is essential that the process described in Figures 70 through 73 be strictly followed to eliminate noise problems from power-conversion devices. Any uncontrolled conductor that is allowed to penetrate the barrier, regardless of its importance, will carry noise current outside the barrier where it can be transferred to other nearby conducting material by inductive and/or capacitive coupling mechanisms or by direct conduction. There is no shortcut to the mitigation process.

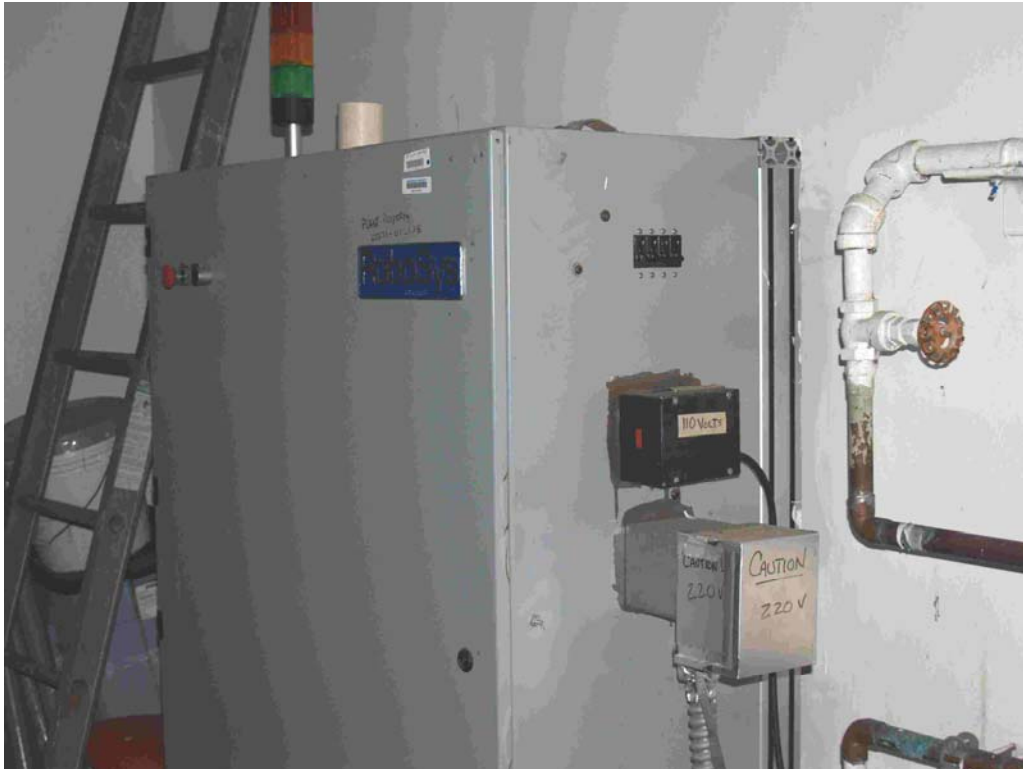
**Figure 74      Filter Installation to Suppress Motor-Controller Noise**

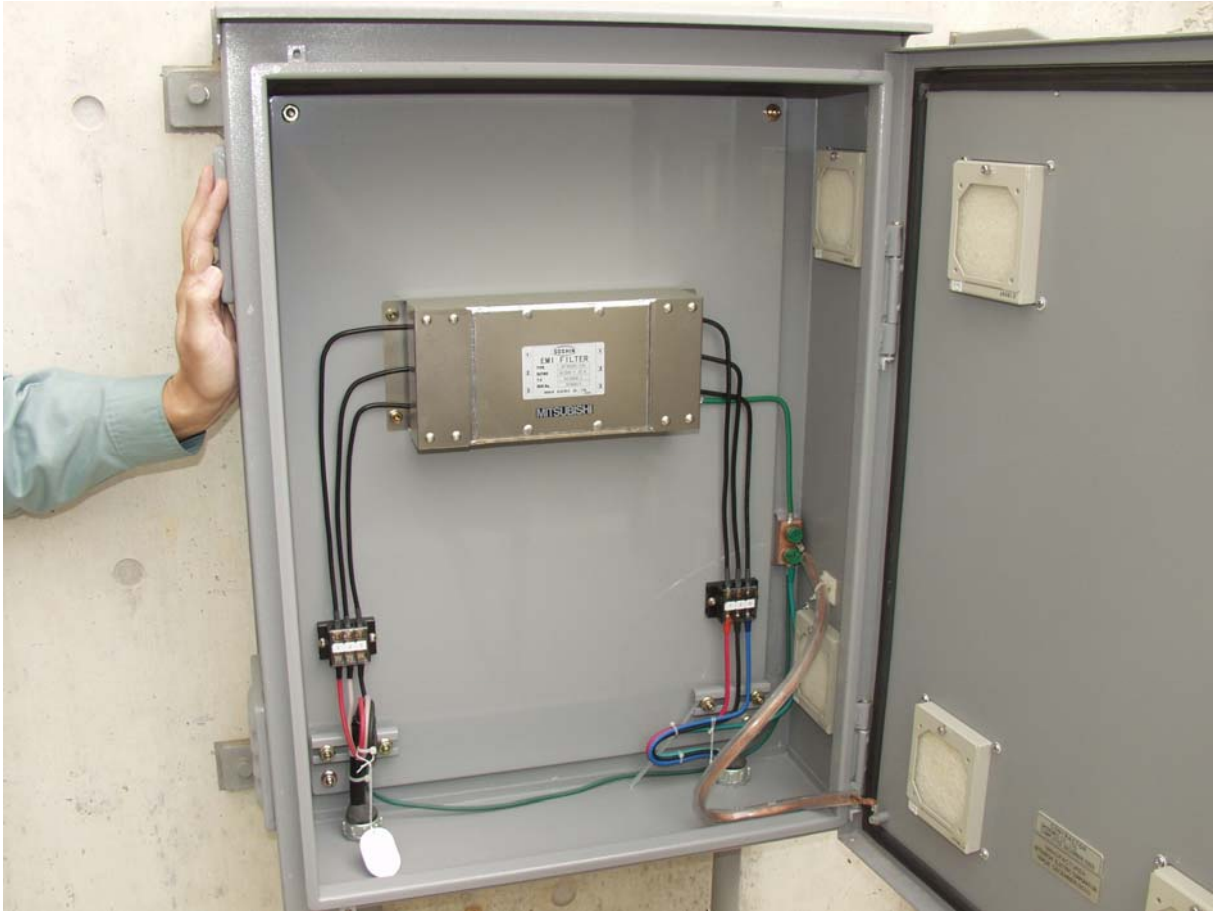
**Figure 75     Improper Filter Configuration**
